Facultad de Odontología
Universidad Nacional de Rosario

Clinical Case

Severe Coronary Fracture Complex Treatment

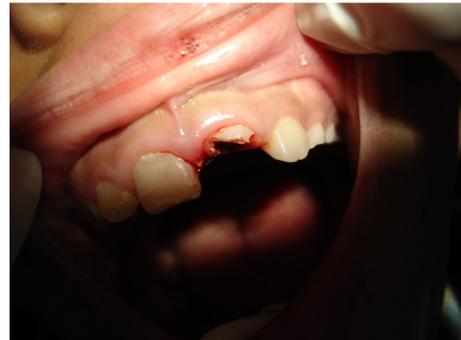
Photo 1

The patient arrived by his own means and because he is a minor he was accompanied by a responsible adult. He had an edematous upper lip. His general systemic state was without any pre-existing pathologies. The patient reported that about 15 days ago he was hit in the face during a football game. The impact of the ball had caused him an almost a total crown fracture of tooth N° 21 with radicular involvement. Some surgical emergency procedures were practiced and then he was derivated to the Endodontic Specialty with the corresponding card with the patient data and the current history of the teeth involved. Partial pulp removal, calcium hydroxide application and reconstruction of the crown with composite had been done.

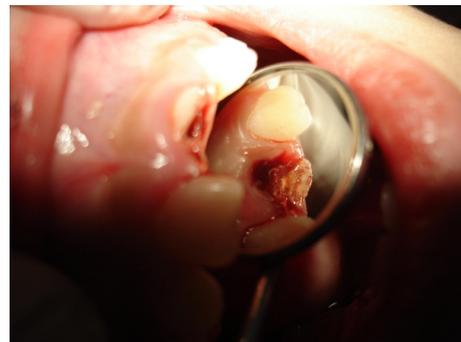
Photo 2

- a) hard tissues. Dental plaque was widespread throughout the mouth. There was absence of N° 84 & 85 teeth and N° 16 & 26 show occlusal amalgam restorations properly sealed and without leaks. The No. 21 tooth had a plastic restoration totally mismatched.
- b) soft tissue. The DP 21 gum was swollen and edematous because of the blow suffered days earlier. He has the upper lip hurt and unremarkable cheeks, tongue and lower lip. It can be observed in the inserted gingival of both arches in the vestibular surface a light brown pigmentation of congenital type.

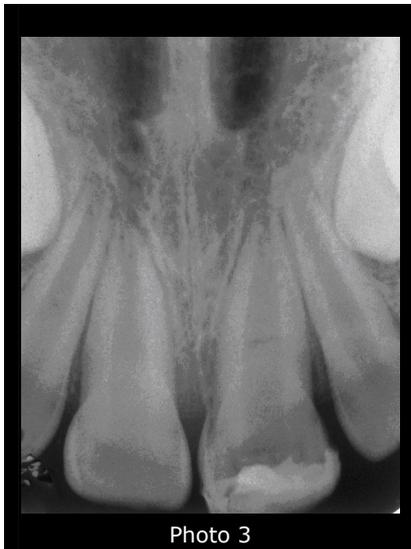
An analogue x-ray of the N° 21 tooth was taken, using the Long-cone technique. A widening of the periodontal ligament space, with incomplete apical maturation but close to be ended was observed. There were enlarged pulp chambers. Distally the alveolar ridge seems to be quite diffuse. The fracture cannot be noticed radiographically, but, mesially there is a radiolucent area, up to the third and a half cervical of the root, as a shift of the alveolar cortical, which looks discontinuous, and the ligament space widened mesially and centrally. Apical root reaching its maturation. N°11 tooth was also taking into account, and it was kept under observation to see how it reacts in apical because it can also might have suffered rupture of the neurovascular bundle due to the proximity to the tooth to be treated.

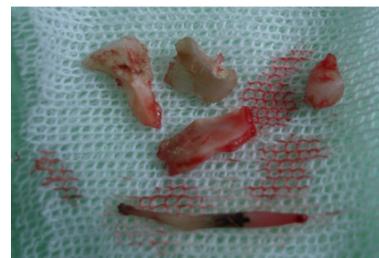
Photo 4

As seen in the picture, dental pulp was exposed to ischemia with its stromal cohesion with congestion and in its initial step of decomposition pathways.

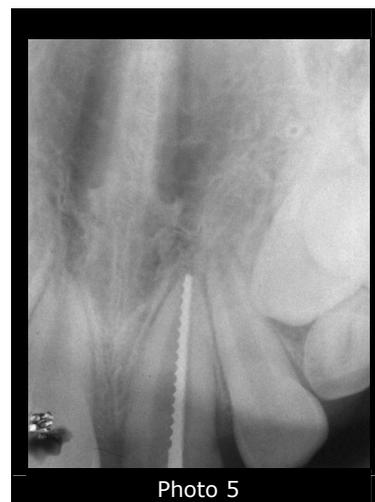
Photo 5

Then, an orthoradial X-ray was taken to corroborate the work length; it was revealed and determined that it was correct. So the work length was established at 18 mm of the remaining coronary-vestibular edge.

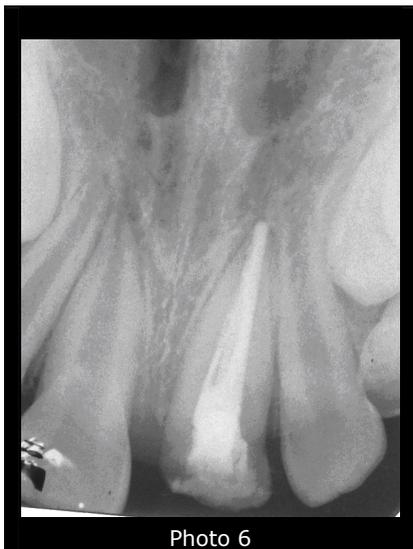
The main cone was Selected: N° 80 (which coincides with the memory instrument preset during the surgical preparation). The adjustment in the conduit was verified taking into account to keep the 18 mm length according to the references already established. Then it was immersed in NaOCl to disinfect the gutta-percha and proceeded to the choice of spacers, which were fitted with rubber stoppers to 2 o 3 mm short of the surgical preparation length With a Lentulo spiral in micro motor the cement was carefully carried to the N° 21 tooth, and then the main cone was cemented. Lateral condensation spaces to the bigger side of the tooth, in this case distally, was done, placing fine accessory gutta-percha cones until the root canal was filled and not enter more accessory cones (Cold Lateral Condensation Technique). Finally, a Landmore instrument was heated to cherry red to cut the cones either just at the conduit inlet and then they were compacted manually with vertical condenser with gentle apical pressure. Lastly a cleaning of the conduit inlet with a cotton swab soaked in alcohol was carried out, also eliminating residual cement sealant. The opening cavity was plugged with zinc phosphate cement. The final radiograph is taken which shows a good seal at the apical level, regular in the middle and mesial parts of the conduit, good seal at the coronal level with continuity between the gutta-percha and the phosphate cement, which ensured against possible leaks.

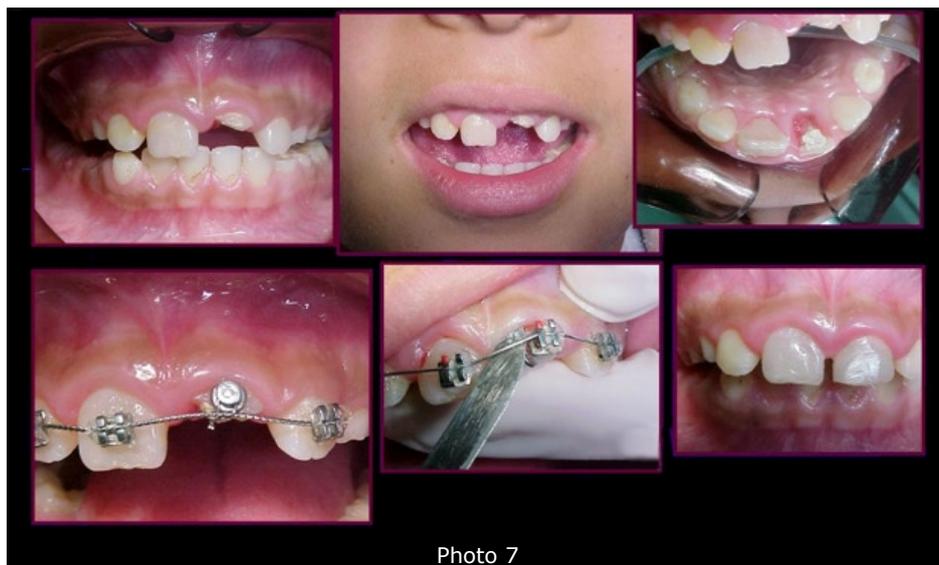
Photo 7

Then a syndesmosis was made fortnightly to eliminate the adhesion of fibers to the root so it was emerging trying to get a biological space for future reconstruction. This was visible with the change of the button to braces (which is larger), and the position of the interincisal papilla was maintained and it was even growing which gave a better aesthetic. The crown section was temporary rebuilt with composite and the interradicular with fiberglass. The total development of the child is expected to be able to implant an abutmen and final crown.

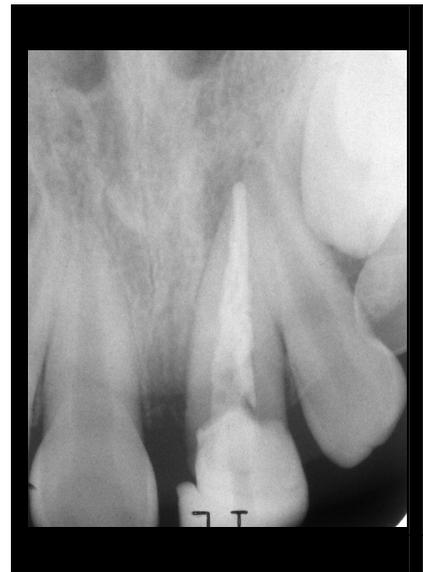
After seven months of endodontic as well as orthodontic and periodontal treatment, the patient attends the established control. The performed restoration was hold in his mouth with good adaptation and quite acceptable aesthetic. The biological space occupied by the interincisal papilla was very well preserved, if we consider the characteristics he had when he arrived to the first consultation after the accident. There was not pain, fistula, edema or tumours. Neither symptoms to the vertical and horizontal soft percussion.

It was radiographically observed a radiolucent image at apical that could be developing tissue. When the periodontal ligament area, where there was displacement of alveolar cortical to mesial and central, is observed it appeared completely healed.

The radiopaque image of the restoration appears well suited distally but somewhat deficient mesially.

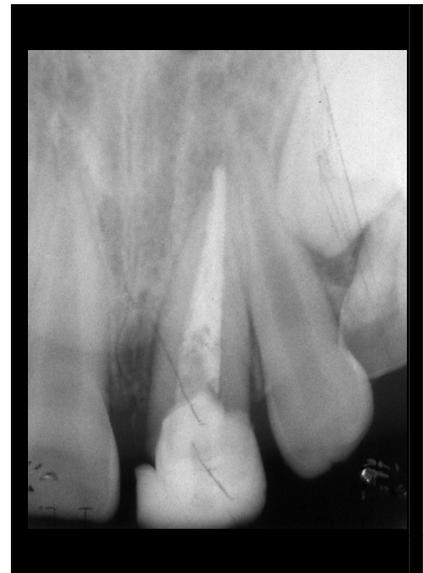
After a year of the final filling, the patient still has the aesthetic restoration made in the mouth by colleagues and in perfect biological clinical and functional state, just like he was five months ago, in the first control. He does not show any symptoms, he is in complete clinical normality, without fistulas, edema, mobility or tumor.

The radiograph shows a visible apical healing and repair improvement. Plastic restoration has the same characteristics that in the previous control.

It can also be observed the ectopic eruption of the permanent canine impacted on the N° 22 lateral, because of lack of space due to be still in the mouth the temporary canine. So he was referred to the orthodontics chair for evaluation.

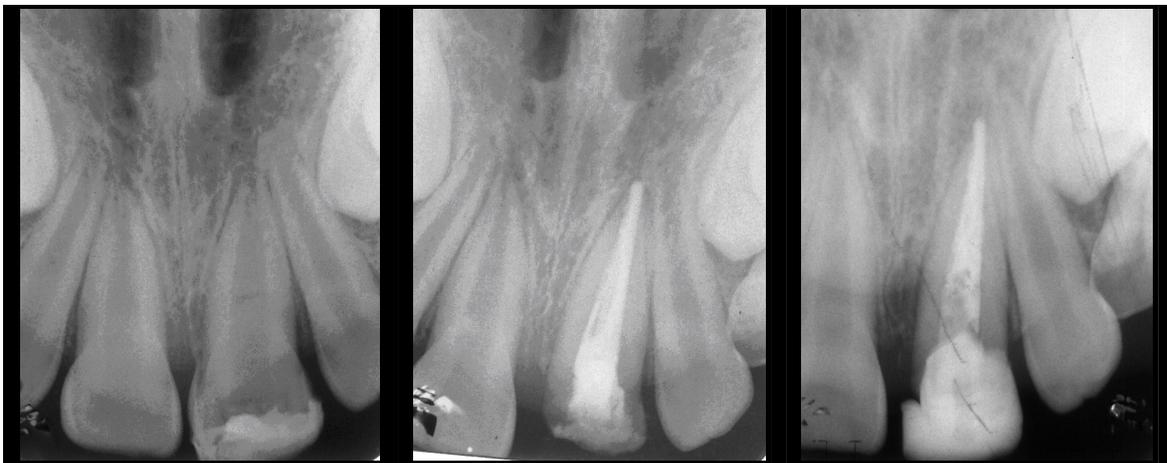
From the beginning of the treatment until the last radiographic control, it is observed at apical level that the periodontal ligament space has dwindled. The root has been slowly matured and it is possible to see a closing line that appears already closing the root, reaching maturity and apexification. The radiographic image of the last control suggests a slow restoration at the apical level where there are no signs of bone resorption or post-treatment pathology. The alveolar cortical doesn't seem to recover, they are still hazy, and at the mesial side more reabsorption could be seen.
